# **Mobile Intel<sup>®</sup> Pentium<sup>®</sup> II Processor Specification Update**

Release Date: May 2002

Order Number: 243887-040

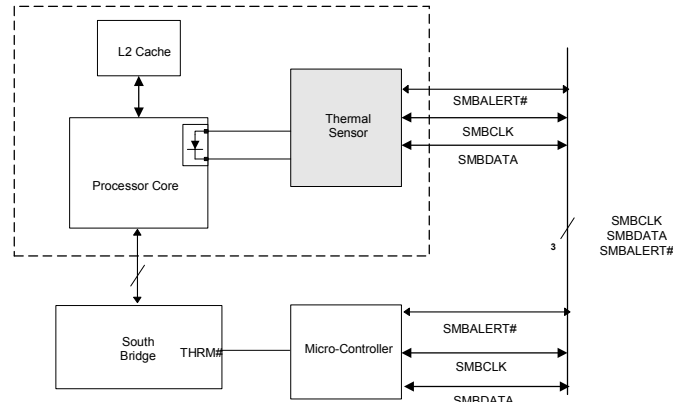
**Figure 1. An Example of Microcontroller Driven Thermal Management**

### B30. Thermal Sensor May Assert SMBALERT# Incorrectly

**Problem:** The Mobile Pentium II processor and the Pentium II Processor Mobile Module have a thermal sensor that monitors the processor core's temperature. Please note that desktop systems could have a similar thermal device. The thermal sensor asserts SMBALERT# if the processor temperature exceeds the temperature limits set in the Alarm Threshold Registers ( $T_{HIGH}$ ,  $T_{LOW}$ ). It also sets the corresponding Status Register bits to identify the cause of the interrupt. Figure 1 gives one example of the how the SMBALERT# signal could be used in a system.

Under the conditions described below, the thermal sensor incorrectly generates the SMBALERT# interrupt. All of the following conditions must be met to trigger a false interrupt:
